Camshaft failure of Skunk2 Stage2 Tuner Series cams for B series engine

The setup

- B18C5 head and block, OEM bottom end
- Skunk2 Stage2 Cams
- Skunk2 Valve Springs and Titanium retainers

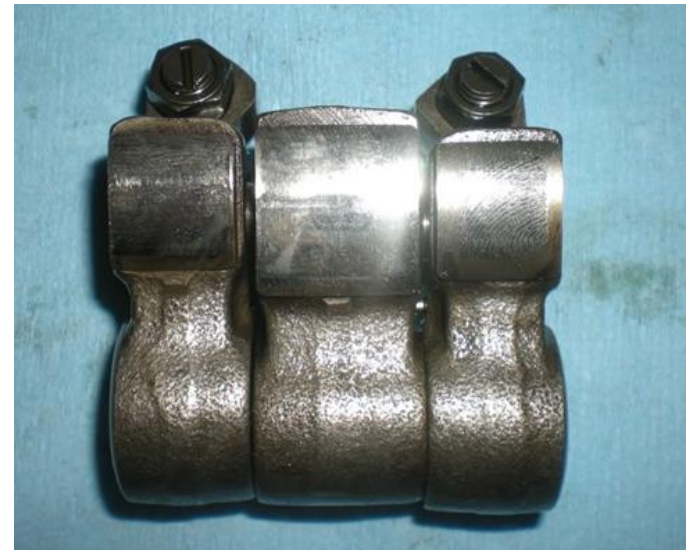
Pics I took prior to cam installation. Note that all rocker pads look good.

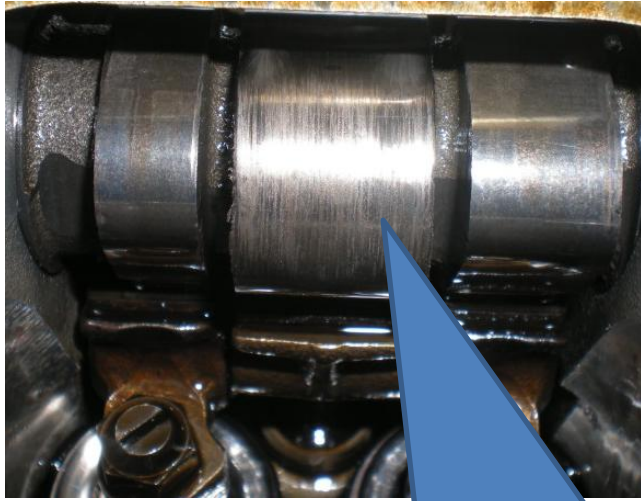
At 3k miles, I pulled the valve cover to inspect valve lash, and found this:

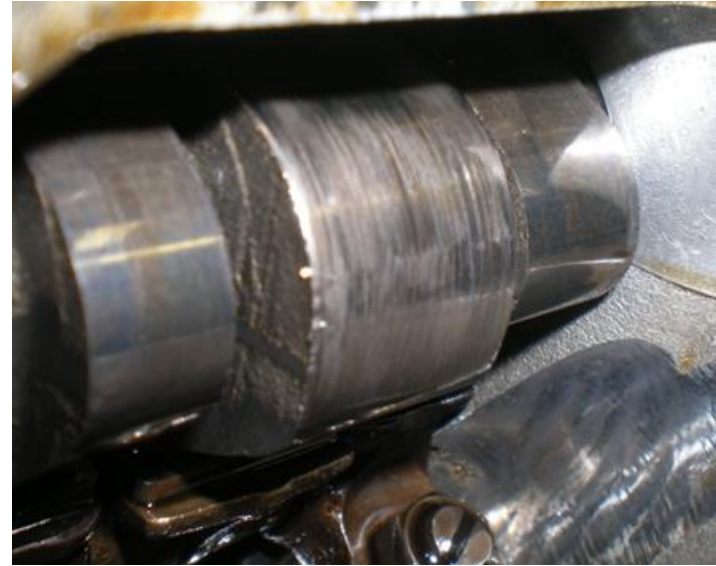
Severe wear on all 4 exhaust cam VTEC lobes (intake cam and all primary & secondary lobes OK)

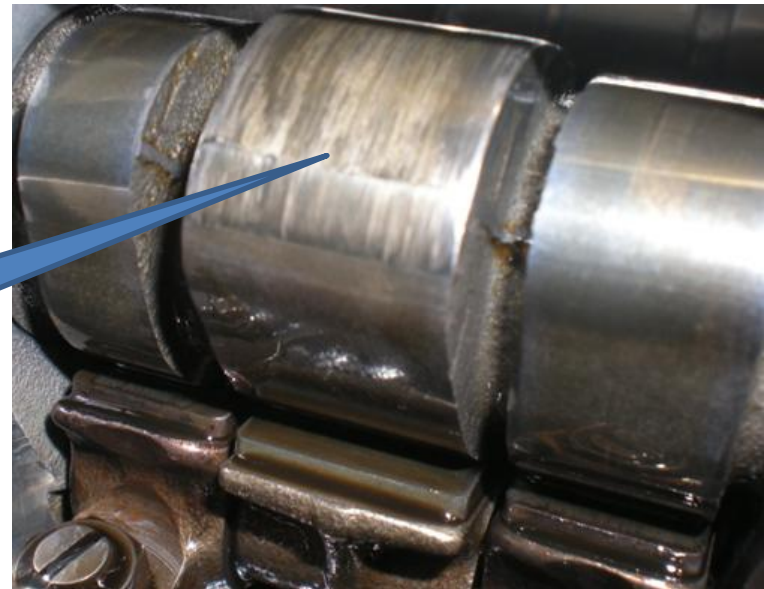
-Parting line evident
-Wear is only on "valve closing"
side of cam lobe

- Probable cause** because cams show consistent wear across exhaust vtec lobe ONLY
- Wear starts at the casting parting line. A line can be felt in this area on the cam lobe
- Parting line witnessing onto cam friction surface caused wear to rockers
- Improper casting can cause weak and porous material to exist around parting line.

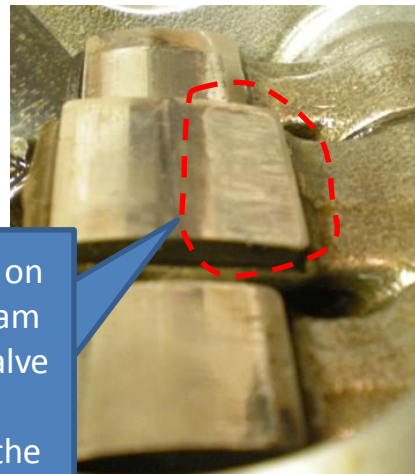
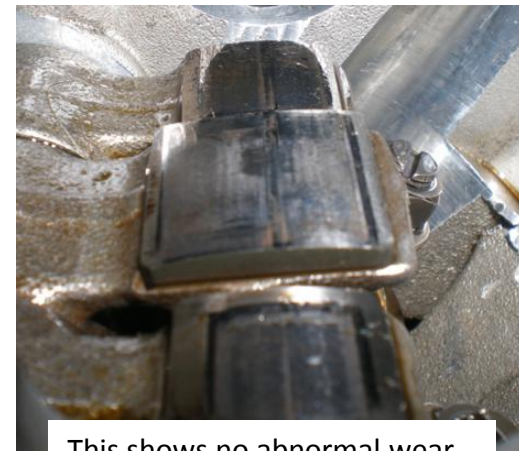
Rocker wear only on pad in the area cam contacts during valve closing. This coincides where the cam shows wear

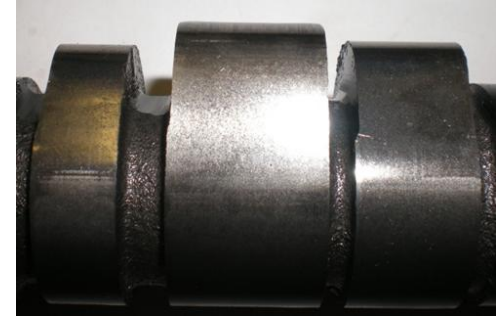
“Valve open” side of cam lobe looks like new

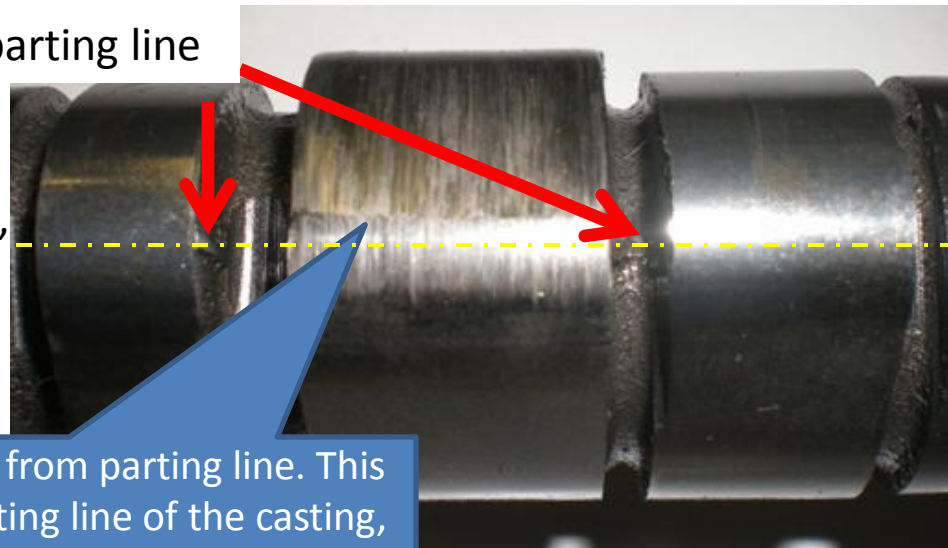
Casting parting line

Very noticeable transition from “good” to “bad” as max lift is reached. Can be felt.

Wear area propagates from parting line. This coincides with the parting line of the casting, leading me to believe it is a material or casting issue

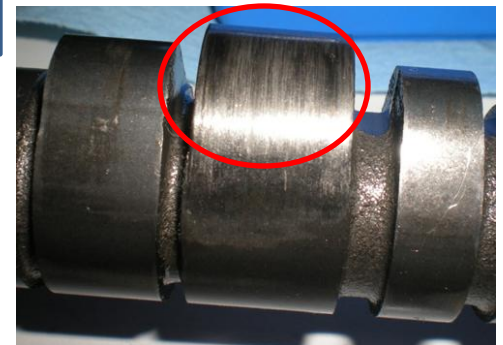
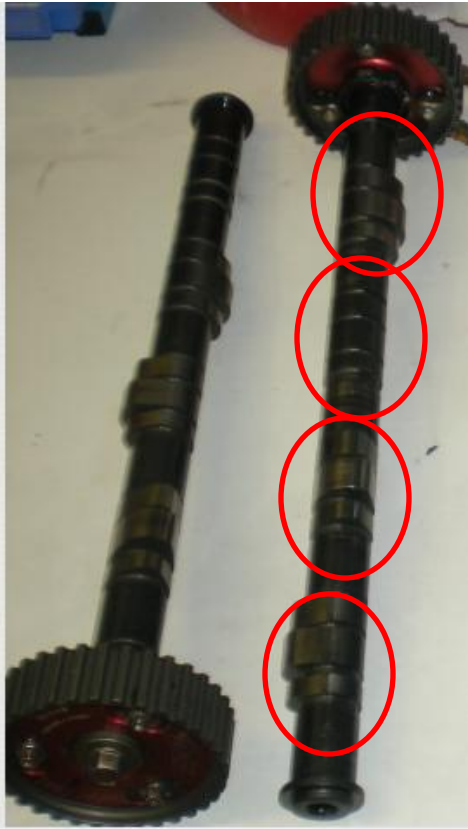
Wear is seen along “valve closing” side of lobe.
