PGM-FI Control System

Troubleshooting Flow Chart — IMA Sensor [Without CATA]

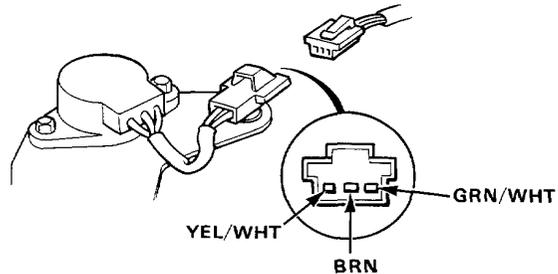
Disconnect the 3P connector from the IMA sensor.

Measure resistance between YEL/WHT terminal and GRN/WHT terminal on IMA sensor harness.

Measure resistance between YEL/WHT and BRN terminals and between GRN/WHT and BRN terminals.

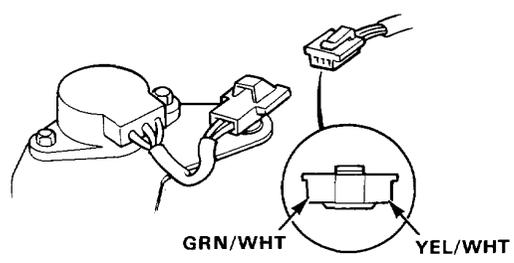
Measure voltage between YEL/WHT (+) terminal and GRN/WHT (-) terminal on the wire harness.

Connect the PGM-FI test harness between the ECU and connector (page 6-19).

Measure voltage between B20 (+) terminal and C12 (-) terminal.

Measure voltage between C13 (+) terminal and C12 (-) terminal.
